**US Army Corps
of Engineers**

Technical Report CHL-99-3
March 1999

Monitoring Completed Navigation Projects Program

Inspections of Previously Monitored Coastal Structures

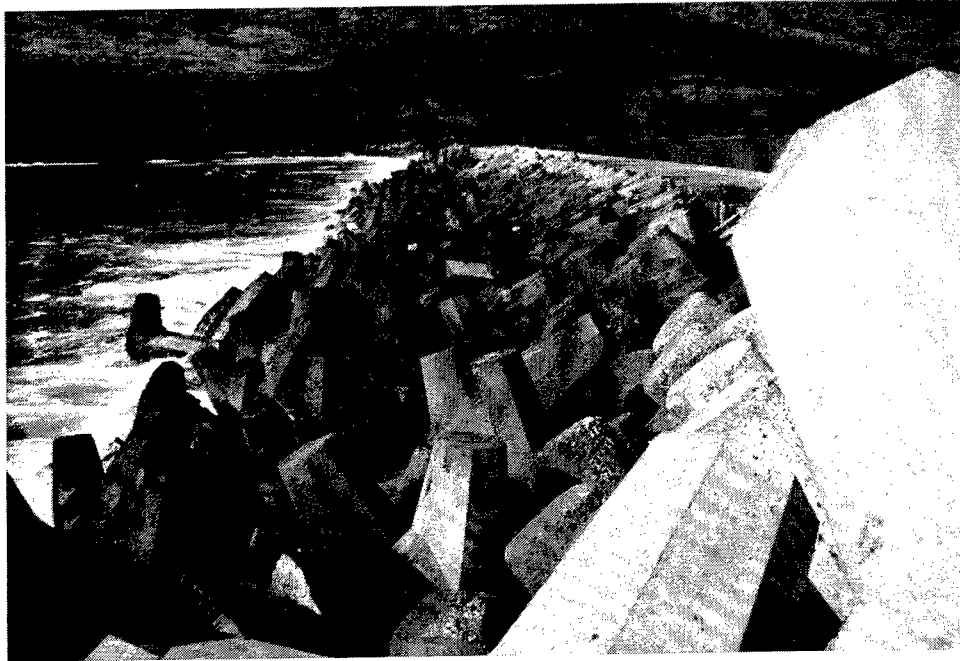
The breakwater (Figure 3) was inspected on 22 July 1998. The inspection indicated that most of the armor units were in similar positions as recorded during the 1995 survey based on detailed photogrammetric maps of the structure. Numerous broken armor units were observed, but were validated as those documented in the 1995 survey. Fragments of some of the broken armor units were still in the same locations as observed in 1995. It was noted that the older 16,150-kg (17.8-ton) tribars are showing major surface spalling of concrete (Figure 4), but this is not felt to put the structure in any danger of instability. Overall the structure is in good condition.

Figure 3. Sea side of Nawiliwili Harbor breakwater

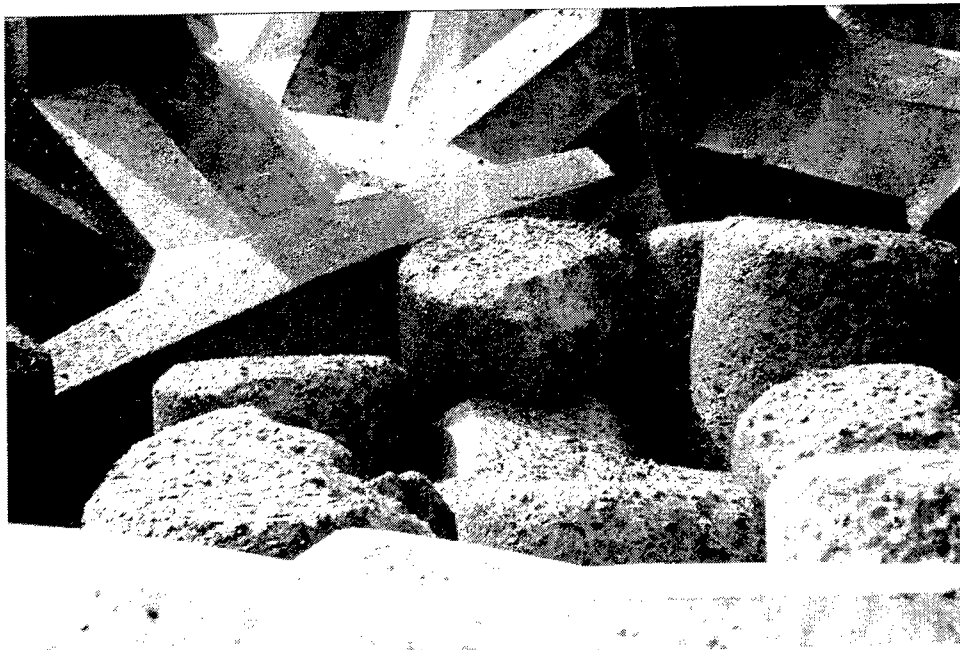
Figure 4. Surface spalling of tribars on Nawiliwili breakwater

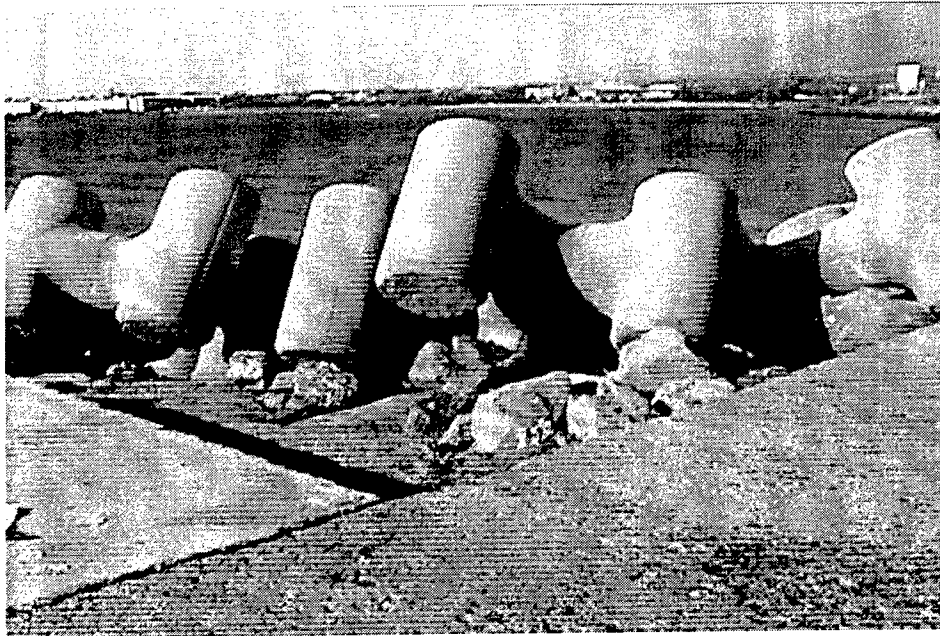
(sta 6+20 thru 7+10) on the sea side of the structure was noted since the 1993 survey. Eleven broken units were observed in this area as opposed to nine documented broken units during the 1993 survey. During the west breakwater inspection, a concentration of broken 27,215-kg (30-ton) dolosse was noted on the sea side of the head. Twelve broken/cracked units were observed versus eleven documented during the 1993 survey. Also, some of the 5,900-kg (6.5-ton) tribars on the harbor side of the breakwater close to its head appeared to have lifted and tilted downslope

(possibly due to overtopping waves, Figure 8). No voids and breaches were noted in the breakwaters, and the overall condition of both structures was considered good.

Figure 8. Tribars that appear to have tilted downslope (Kahului west breakwater)

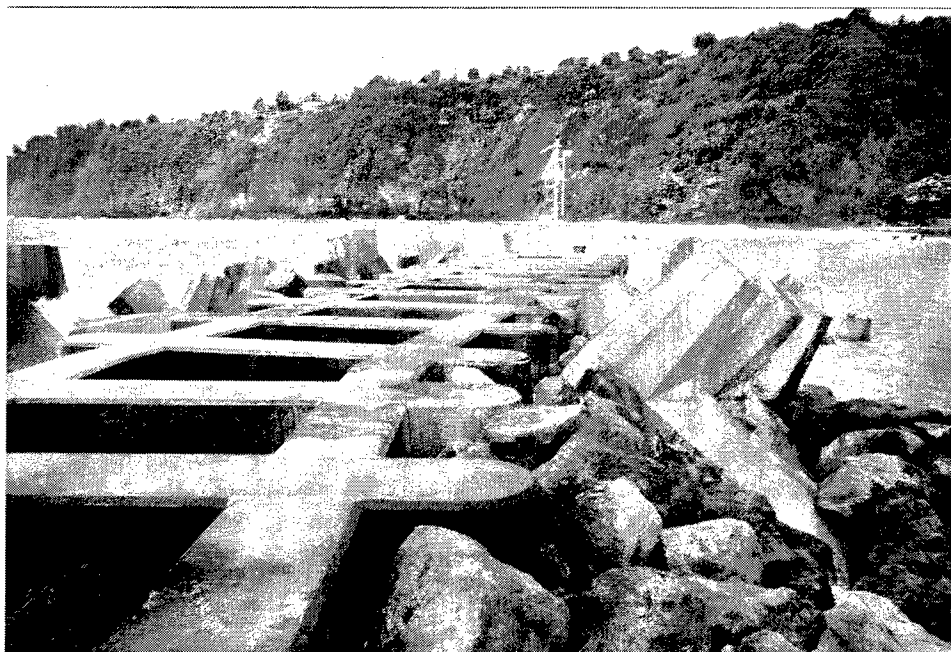
The Laupahoehoe breakwater (Figure 10) was inspected 22 July 1998. The inspection indicated that the armor units were in the same positions

Figure 10. Laupahoehoe breakwater

as documented in the 1993 survey. No broken armor units were observed, and the structure is considered to be in excellent condition.

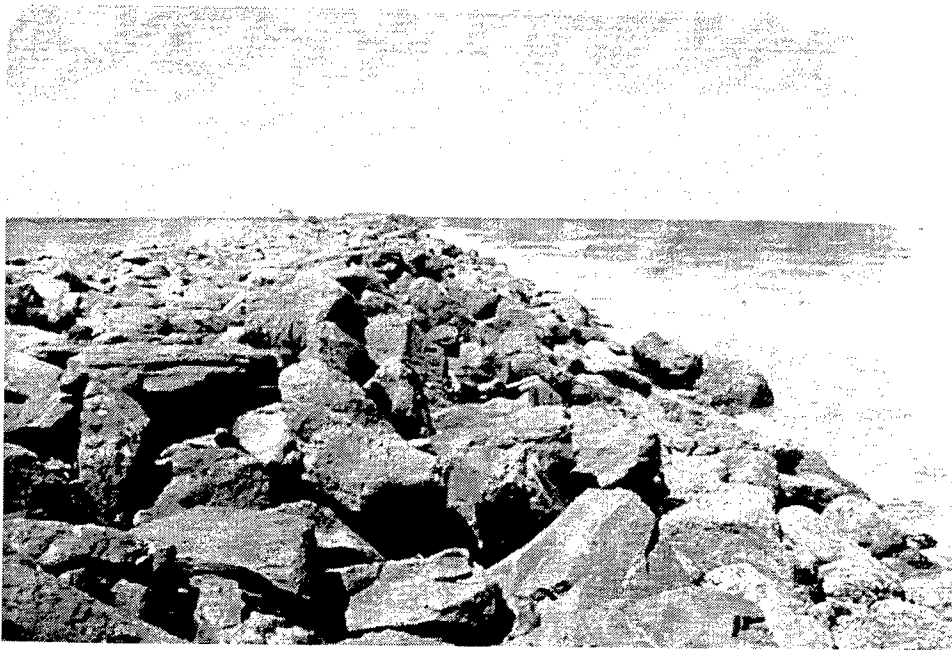
An inspection of the north jetty (Figure 12) on 24 June 1997 revealed that the head of the structure no longer existed. Comparisons to photogrammetric data obtained in May 1993 indicated that approximately 50 m (165 ft) of the north jetty head was no longer above water, and stone had apparently been removed to below the water level by wave action. When the notch area was not visible, measurements from known locations on the structure were made to confirm this finding. Remnants of some of the jetty could be seen seaward of the structure in wave troughs as they passed. Above-water stone around the head was not uniform (Figure 13). Other observations of the structure revealed some low areas in the crest and some voids on the sea side of the jetty. At a location approximately 305 m (1,000 ft) shoreward of the jetty head (the head location of 24 June 1997), low areas in the crest existed over about a 30.5-m (100-ft) span.

Figure 12. Yaquina Bay north jetty

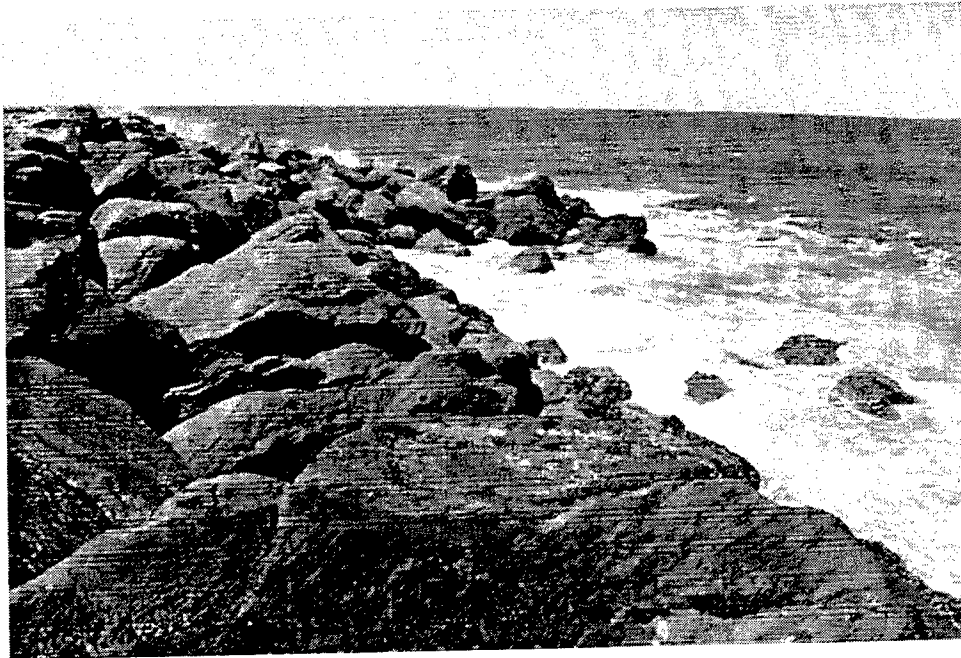
Figure 13. Head of Yaquina Bay north jetty on 24 June 1997

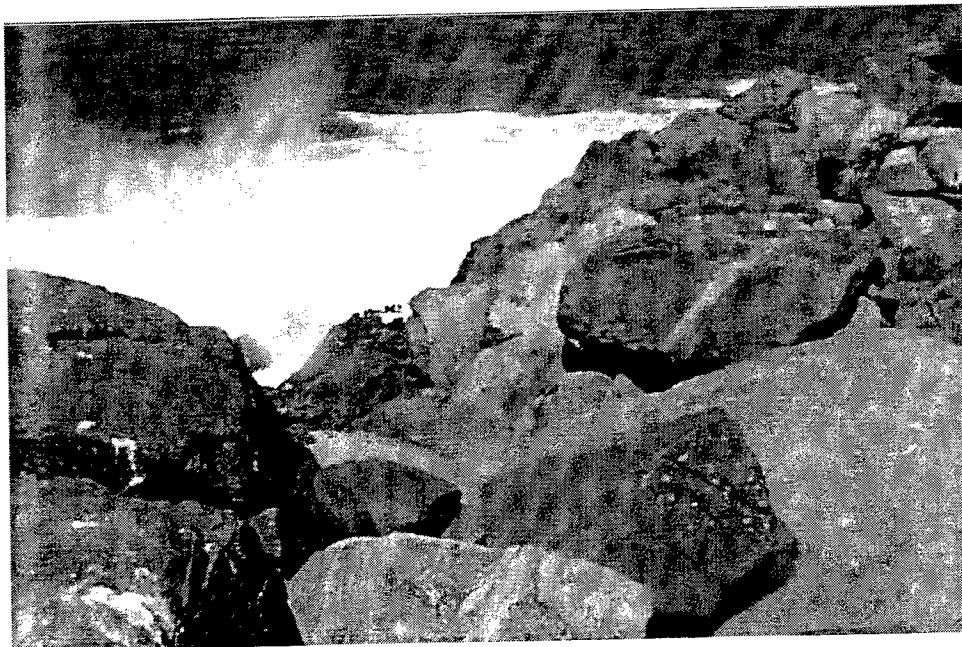
Another low area was observed on the crest about 520 m (1,700 ft) shoreward of the jetty head, and a void on the sea side of the jetty was observed approximately 580 m (1,900 ft) from the jetty head (Figure 14). An even larger void on the sea side of the structure was observed about 650 m (2,125 ft) shoreward of the jetty head as shown in Figure 15.

Figure 14. Void on seaward side of Yaquina north jetty observed approximately 580 m (1,900 ft) from head

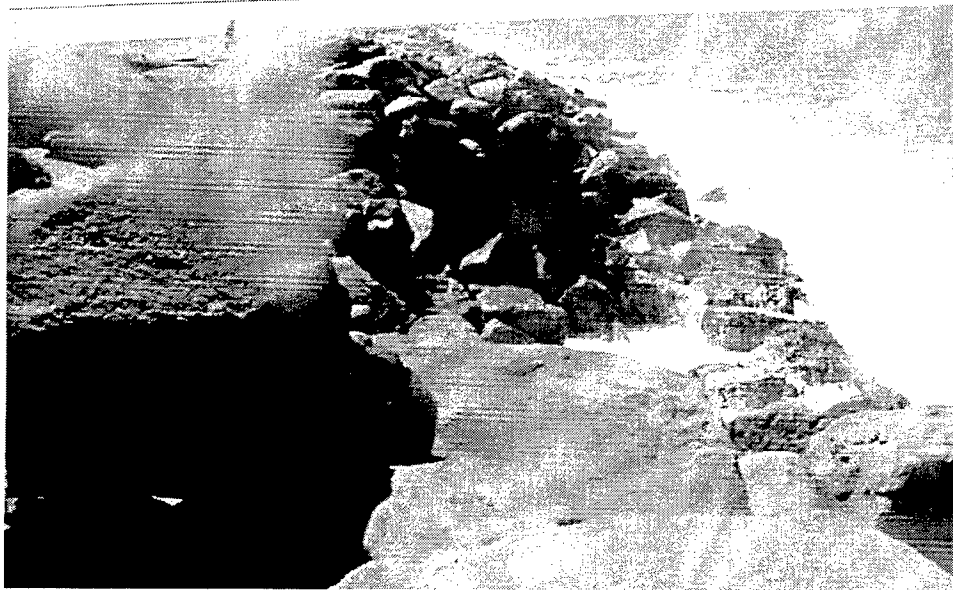
Figure 15. Void on seaward side of Yaquina north jetty observed about 650 m (2,125 ft) from head

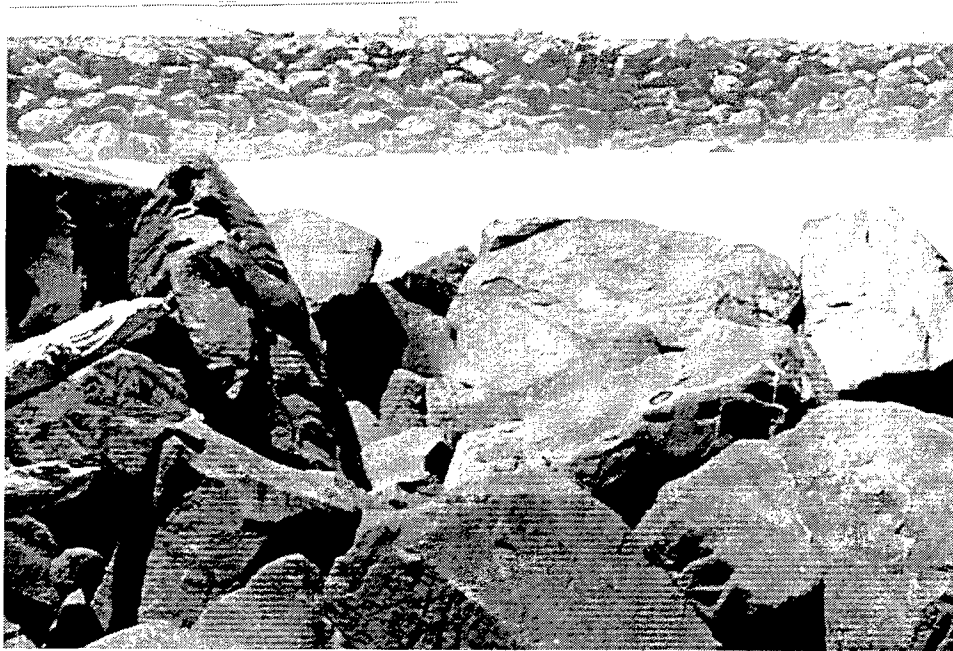
An inspection of the jetty system on 26 June 1997 revealed that some repairs were needed. On the north jetty head, a void was observed on the channel side of the structure. The area was steep, and it appeared that stone had been pulled downslope by wave action as remnants could be seen seaward of the area. About 20 m (65 ft) shoreward of the jetty head, a low area in the center of the crest existed; and approximately 27.5 m (90 ft) from the head a void existed on the channel side of the structure. In several areas along the jetty extension, it appeared that the center portion of the crest had subsided and the elevation was irregular. The stone along the slopes, however, appeared to be up to required elevation. At a point about half the length of the jetty spur, it appeared a stone had been up-lifted leaving a small void (Figure 17). With the exception of the jetty head, the slopes on the north jetty extension and jetty spur were in good condition. Inspection of the south jetty extension indicated a similar situation at the jetty head on the sea side of the structure. The slope was very steep, and it appeared that stone had been pulled downslope by wave action (Figure 18). The head of the south jetty spur also was damaged on its shoreward side as evidenced by a lack of stone above the water surface (Figure 19). In addition, immediately shoreward of the jetty spur head, a void existed on the shoreward side of the spur (Figure 20). The side

Figure 17. Displaced stone on north jetty spur at Siuslaw

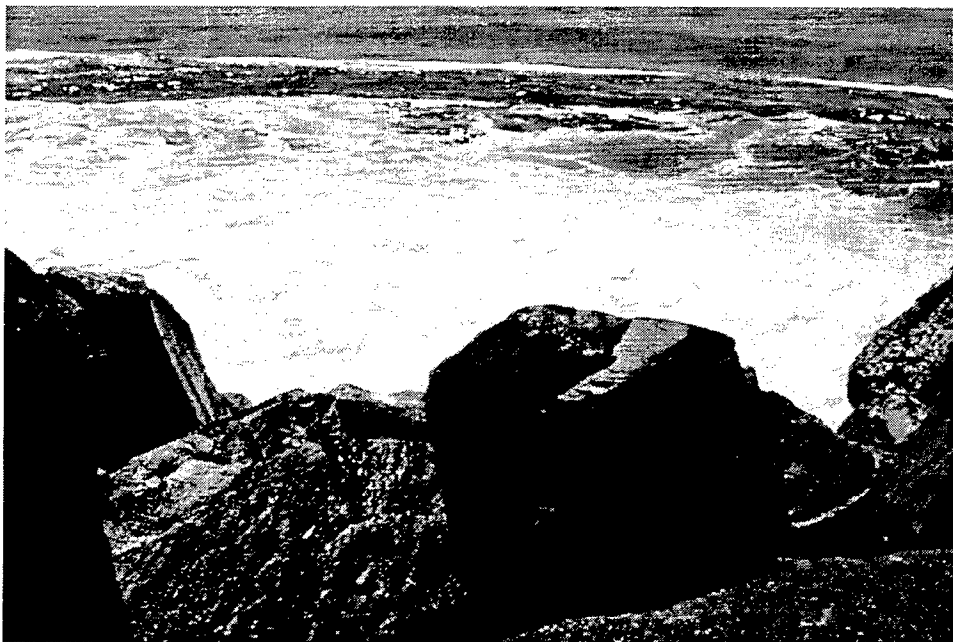
Figure 18. South jetty head at Siuslaw

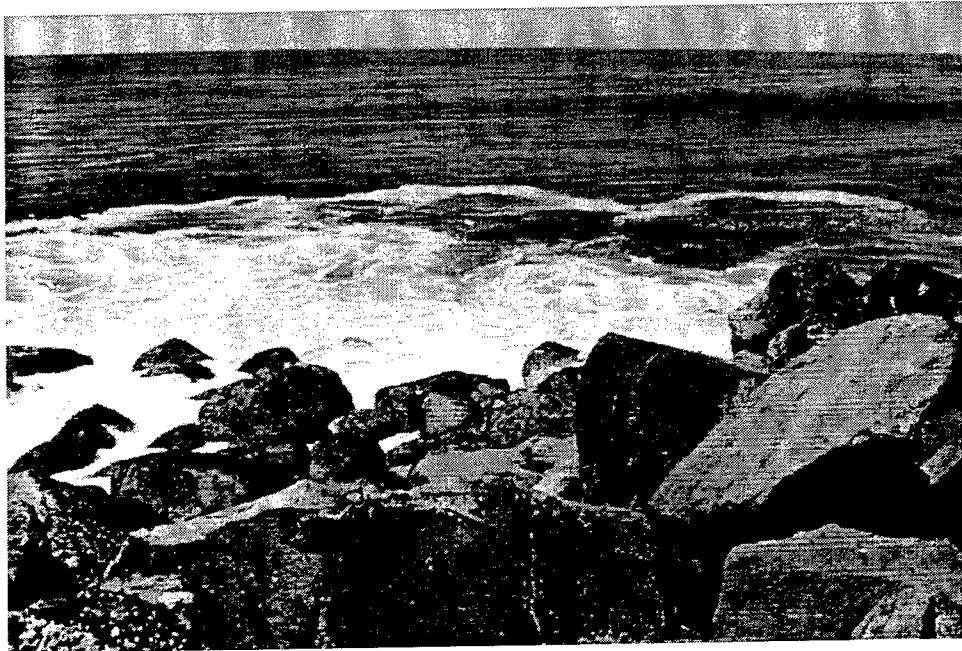
Figure 19. Head of Siuslaw River south jetty spur

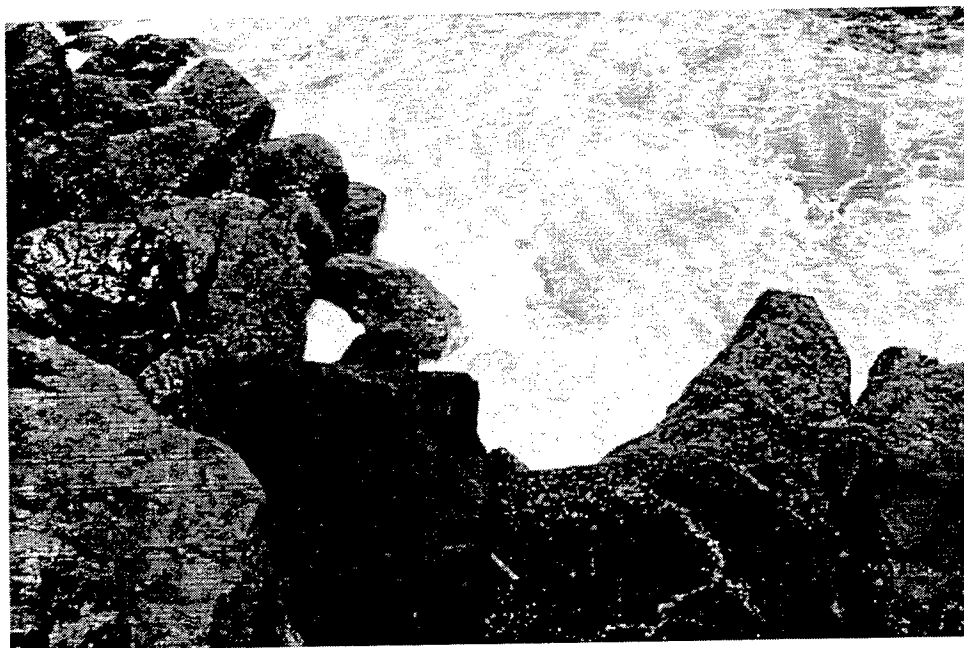
Figure 20. Void in south jetty spur at Siuslaw

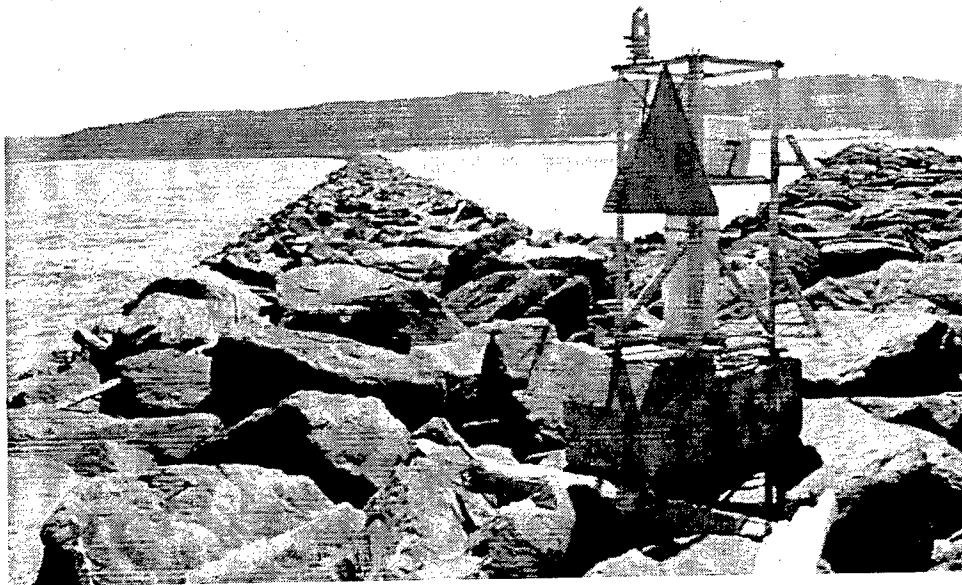
The training jetty and south jetty were inspected on 25 June 1997. Inspection of the training jetty revealed that the 1980 extension was in very good condition (Figure 22). Its cross section appeared to be uniform along its length, and very few of the armor stones had cracked. The shoreward portion of the structure (1951 construction) had some areas that appeared to be damaged on the shore side. This was prevalent immediately landward of the shoreline where stone from the back side of the jetty was scattered (Figure 23). The channel-side face of this portion of the training jetty was in good condition. Inspection of the south jetty revealed a

Figure 22. View of Umpqua River training jetty (left structure) looking shoreward

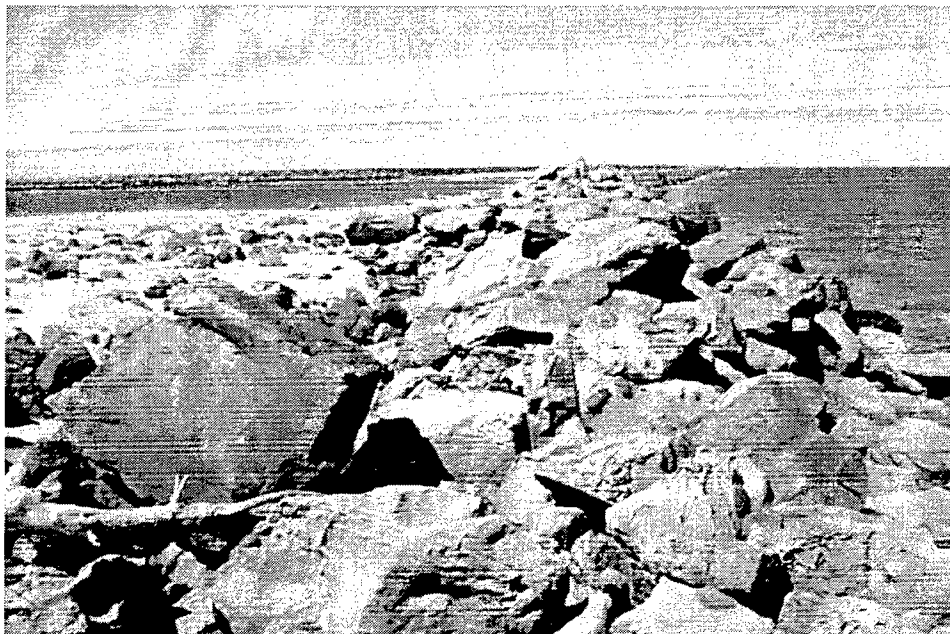
Figure 23. Scattered armor stone on shore side of Umpqua training jetty

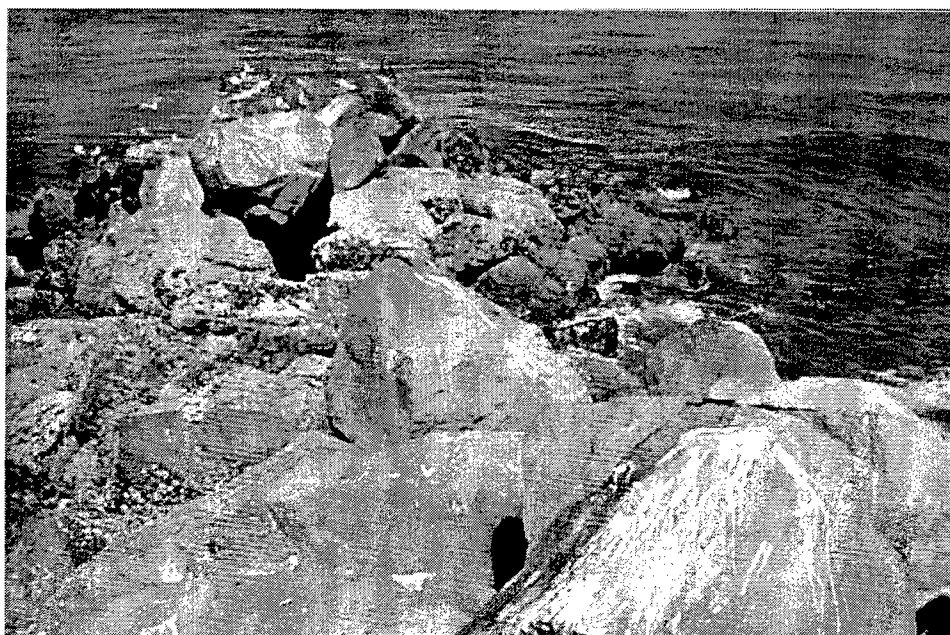
breach at its head. The breach did not extend below the water level, but extended through the jetty (Figure 24). In addition, just shoreward of the breach, a large void existed on the sea side of the structure (Figure 25). The trunk of the south jetty was in good condition.

Figure 24. Breach at head of Umpqua River south jetty

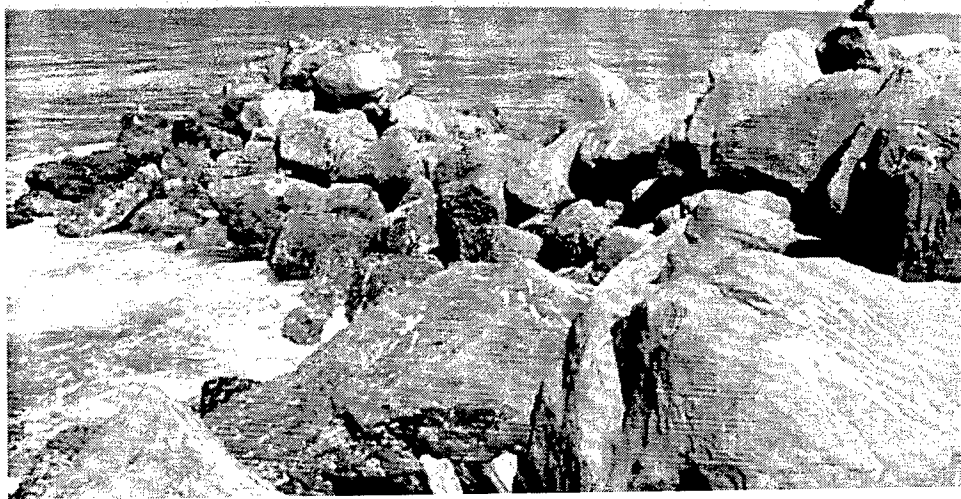
Figure 25. Breach and void at head of south jetty at Umpqua River

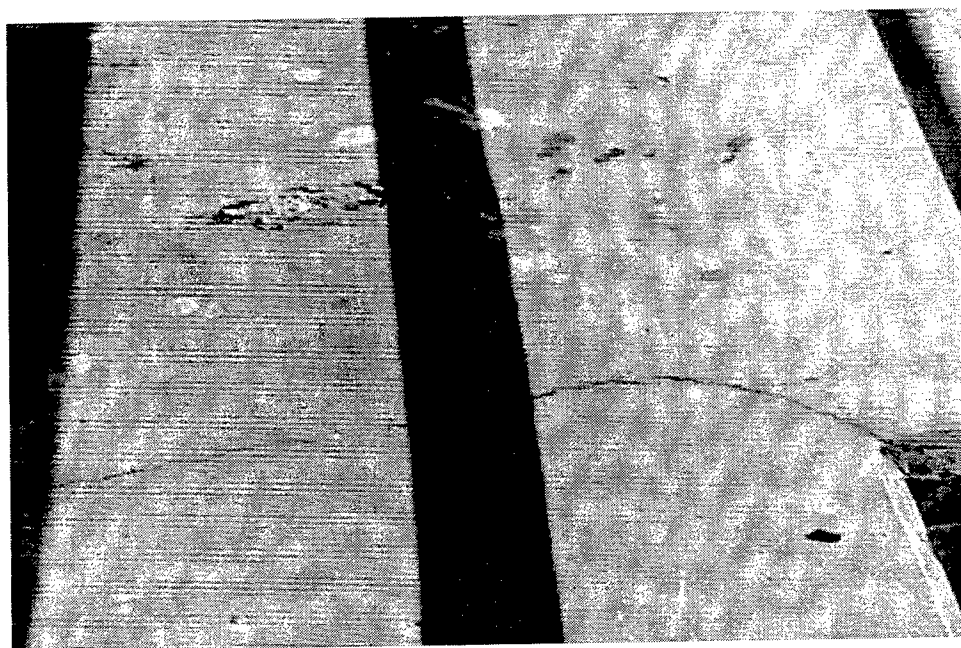
The Spud Point Marina breakwater (Figure 30) was inspected on 16 September 1998. The assessment revealed no evidence of misalignment, movement, spalling, or subsidence of the structure. The hairline cracks across the top of the breakwater cap noted in the earlier surveys did not appear to have widened (Figure 31). Additional hairline cracks were observed, particularly on the vertical sides of the cap. Some of these cracks

Figure 31. Hairline crack across cap of Spud Point Marina breakwater

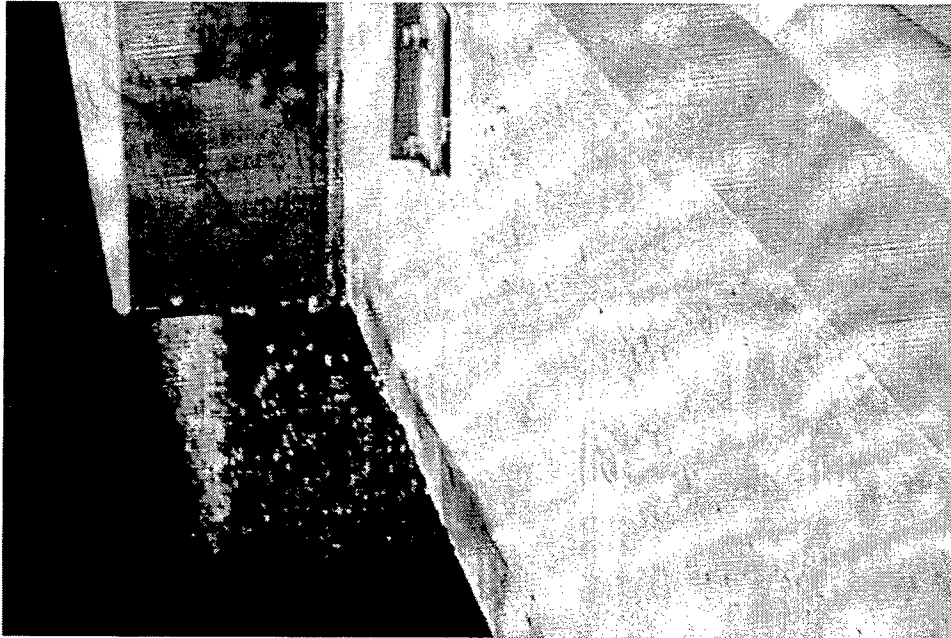
were vertical, but the majority were horizontal cracks formed about 152 mm (6 in.) above the bottom edge (Figure 32). Stains on the concrete along some of these hairline cracks indicated that some of the rebar is rusting in these areas. Cracks along the baffled sections and batter

Figure 32. Example of cracks noted in vertical portions of concrete cap at Spud Point Marina breakwater

piles were not visible due to the buildup of barnacles on the structures. There is no evidence that the hairline cracks in the breakwater cap are threatening the integrity of the structures. Overall, the structure appears to be in very good to excellent condition.

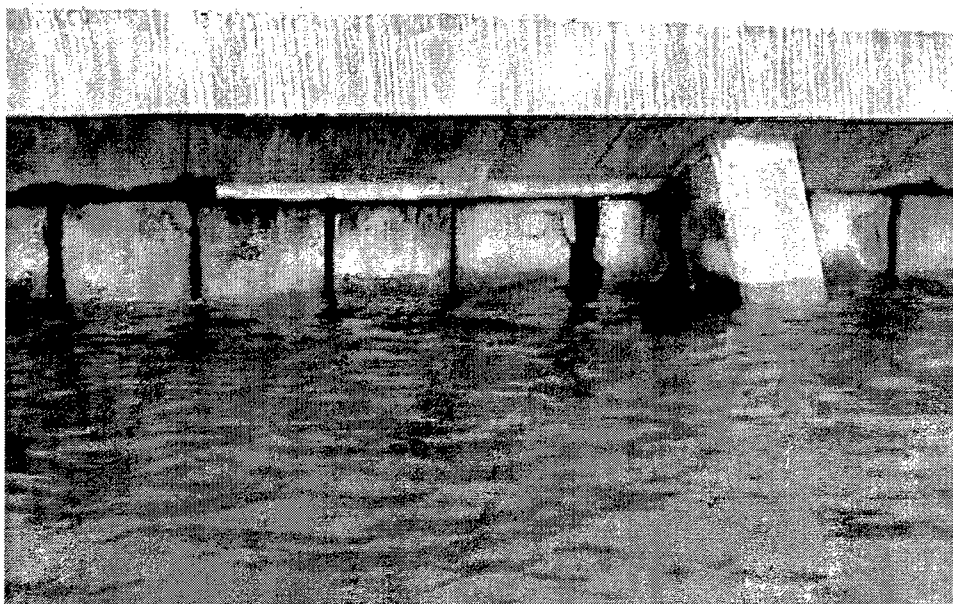
Figure 35. Spalling of concrete piles between the breakwater cap and the water surface at Fisherman's Wharf Harbor

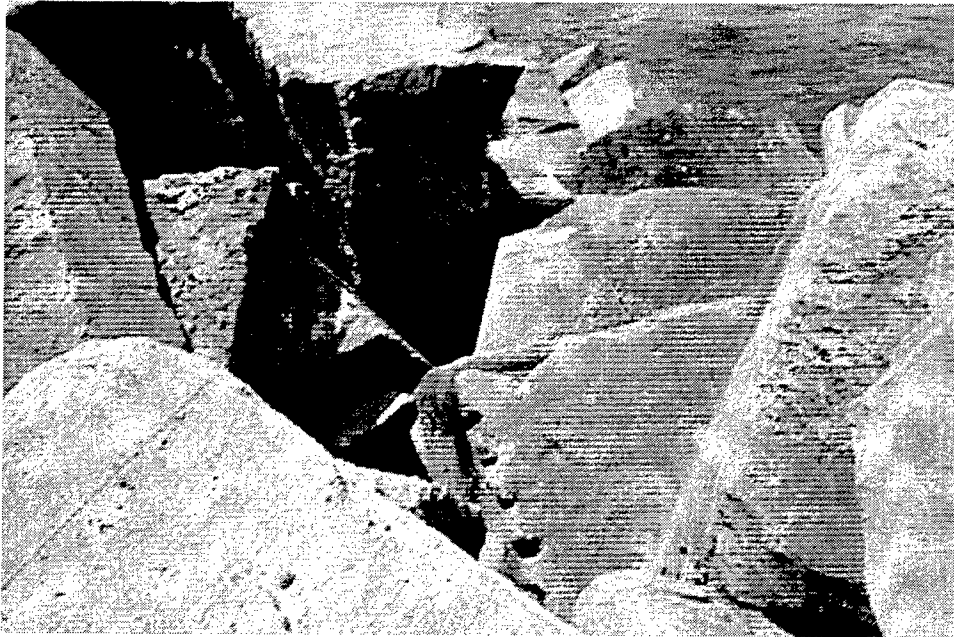
The inspection also indicated several voids in the breakwater. Figures 39 and 40 depict typical voids in the Burns Harbor structure. It appeared that continued deterioration of the breakwater had occurred since the last inspection.

Figure 39. Void on lakeward crest of Burns Harbor breakwater

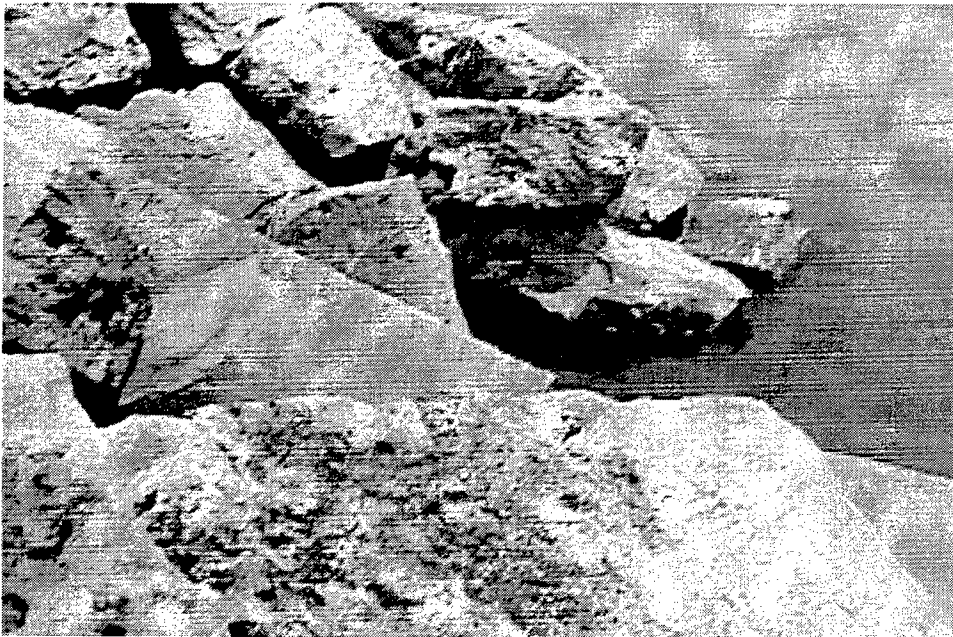
Figure 40. Typical void in harbor side of Burns Harbor breakwater

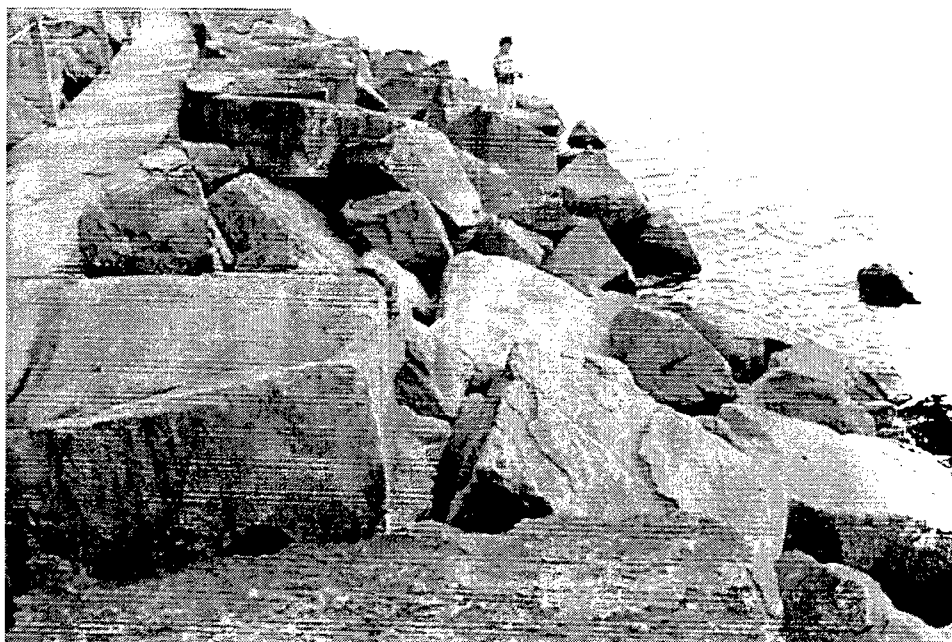
An inspection of the Cattaraugus Creek Harbor south breakwater (Figure 45) on 8 October 1997 revealed voids in the armor stone layer at two locations on the lake side of the breakwater along the curved portion (sta 15+00 and sta 16+50). The void at sta 16+50 is shown in Figure 46. An additional void was observed on the head of the structure (Figure 47), which resulted in a steep slope. During the inspection several broken stones were observed sporadically along the structures; however, overall the structure appears to be in good condition. The north breakwater was inaccessible and not inspected. It is protected by the curved south structure.

Figure 46. Void along trunk (sta 16+50) of Cattaraugus Creek south breakwater

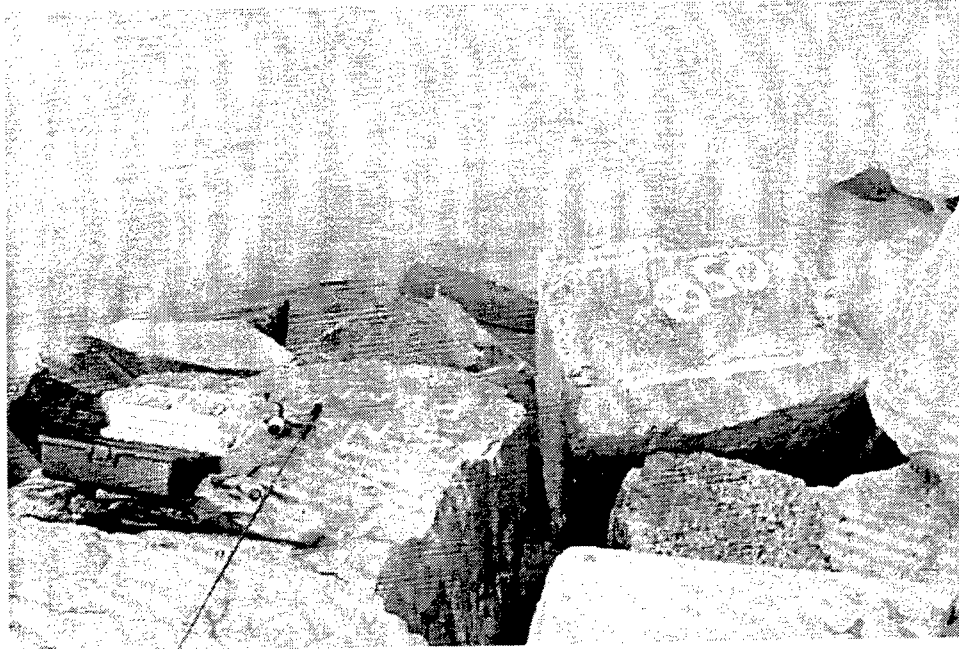
Figure 47. Void and steep slope at head of Cattaraugus Creek south breakwater

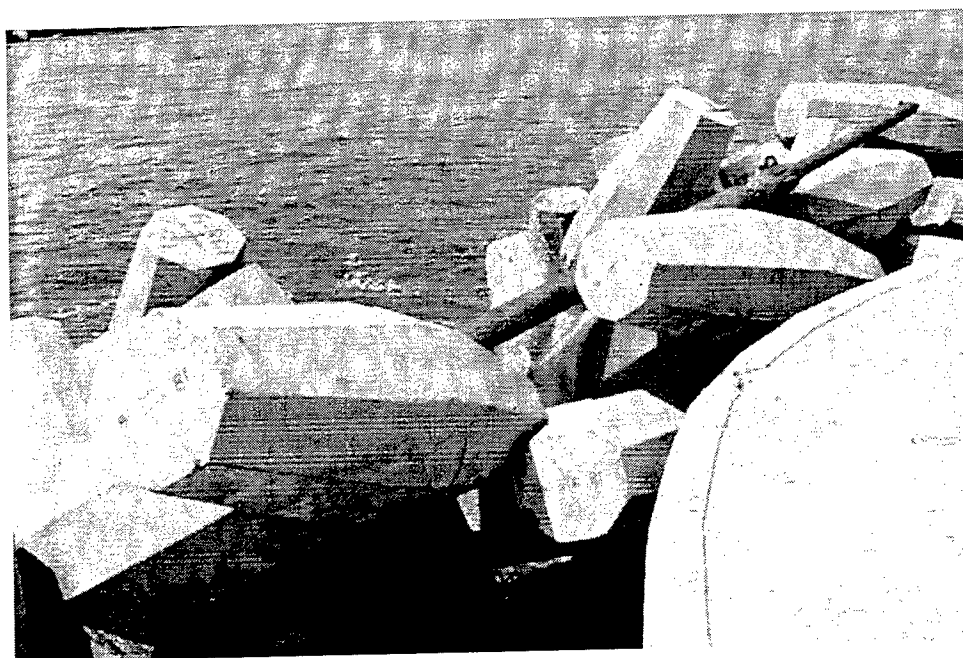
elevation. Seven of these units were adjacent to the void area (Figure 50) on the south side of the jetty head, which had been identified in the 1994 survey. The void area also appeared slightly larger than in 1994. Two armor units on the north side of the structure and four on the seaward tip of

Figure 50. Void area on south side of Manasquan Inlet north jetty head

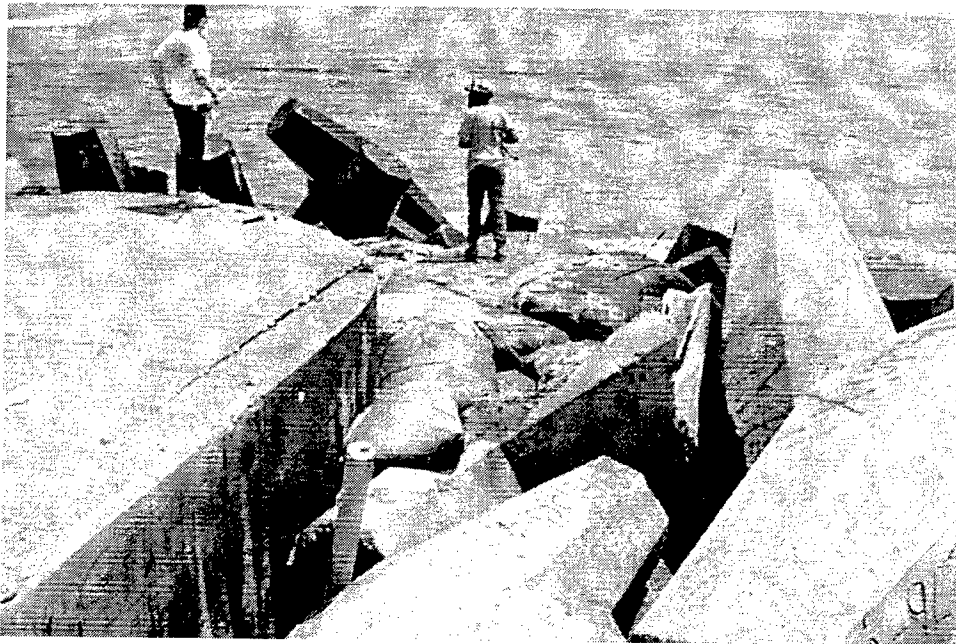
Figure 51. Emergency repair work (grout-filled bags) at head of Manasquan Inlet south jetty

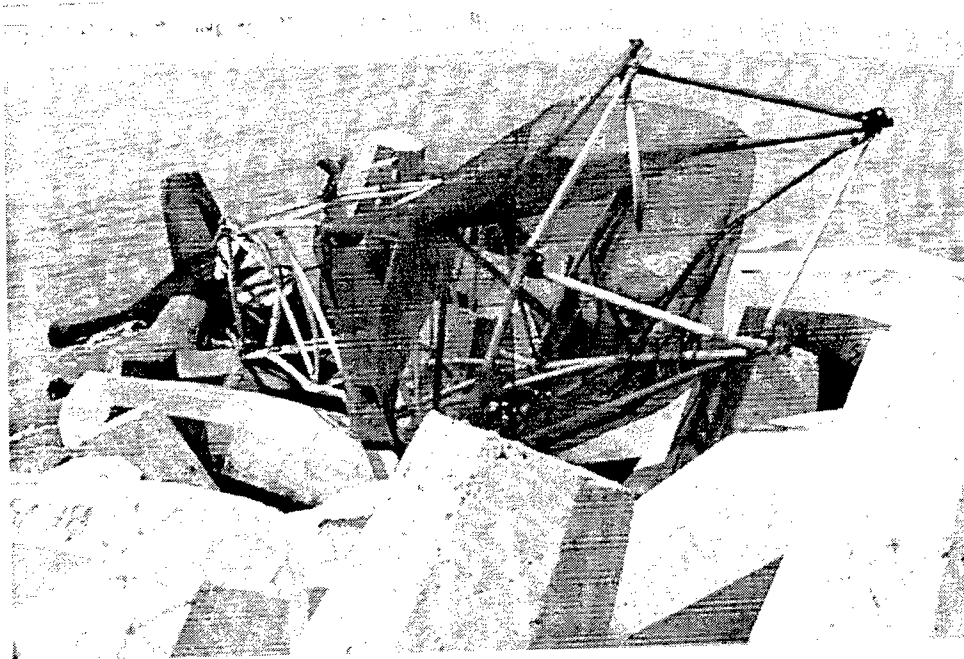
Figure 52. Lighthouse base washed into Manasquan Inlet south jetty as a result of 1995 storm

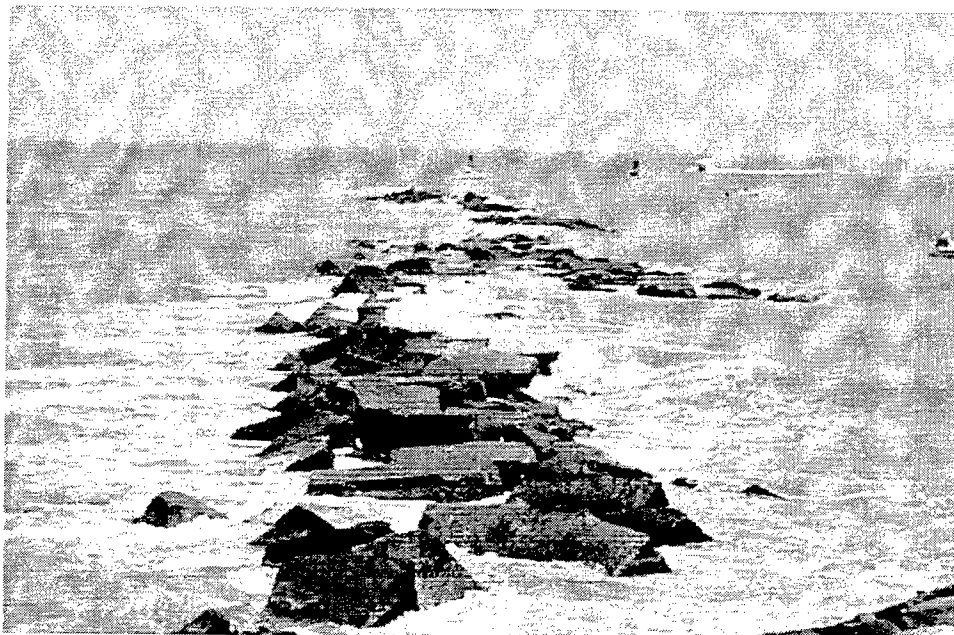
The rehabilitated south jetty and headland breakwaters at Ocean City Inlet were inspected on 11 June 1997. The rehabilitated south structure is shown in Figures 54 and 55, and the headland structures are shown in Figure 56. The inspection revealed these structures to be in excellent condition. No voids were noted, no armor stones were broken, and the cross sections of the structures appeared to be as built. It was noted that the seaward section of the old south jetty (that extending beyond sta 13+00) was in disarray. Armor stones were scattered, the crest height was inconsistent, and no definite cross section was apparent (Figure 57).

Figure 57. Seaward section of existing south jetty at Ocean City Inlet (beyond sta 13+00)
